Eleven-year clinical performance of a premolar restoration made of an indirect microfilled composite material: a case report

(Asian Pac J Dent 2014; 14: 19-21.)

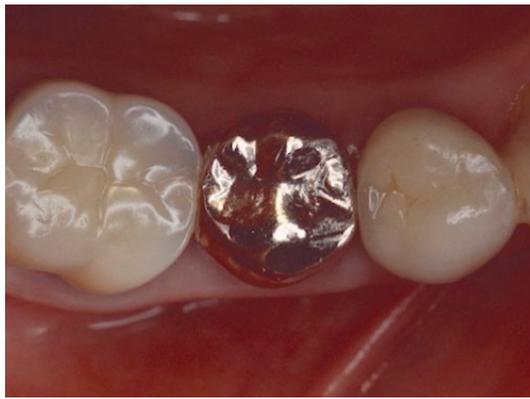
1

Fig. 1. Pre-operative view of the second premolar and adjacent teeth
Fig. 2. Dowel core made with a fiber-post and a composite material
Fig. 3. Fiber sheet placed on the abutment cast
Fig. 4. Composite restoration made with Gradia material
Fig. 5. Worn composite restoration (11 y and 4 m after seating) and fractured first premolar (PFM restoration)

A 57-year-old female patient presented with a chief complaint of masticatory disturbance associated with gingival recession and decay of her right mandibular second premolar. The second premolar had undergone treatment with a metallic restoration made of silver-palladium-copper-gold alloy, which was functioning for more than 5 years. The adjacent first molar was treated with a metallic restoration veneered with a hybrid composite material. Further, a porcelain-fused-to-metal (PFM) restoration had been placed on the first premolar. Examination revealed that the second premolar was not vital, and secondary dental caries along the cervical margin of the tooth was detected. Several treatment options were proposed; 1) metallic restoration, 2) composite restoration, 3) ceramic restoration, and 4) PFM restoration. The patient chose the tooth-colored composite restoration. The restorative procedure was then explained in detail and consent from the patient was obtained. A summary of the restorative procedure for this case was previously reported.⁸
