Repair of an anterior fixed partial denture with a resin-bonded overcasting and a dual functional metal priming agent: A clinical report

This clinical report describes the repair of a fixed partial denture (FPD) with fracture of porcelain using an overcasting. Porcelain veneer of a maxillary six-unit FPD made of cobalt-chromium was fractured. Veneered areas were cut with a diamond rotary instrument, and an overcasting restoration was made with gold alloy and feldspathic porcelain. The two-unit overcasting restoration was seated with a combination of the Alloy Primer conditioning agent and Super-Bond adhesive resin. The repaired FPD, overcasting, and abutments have been functioning satisfactorily for more than two years and two months. (Int Chin J Dent 2006; 6: 17-20.)

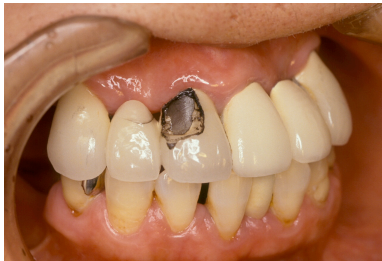
Fig. 1. Fractured porcelain veneer.

An overcasting restoration is usually applied to repair a multi-unit FPD. This technique, however, is contraindicated in cases of failure of bond between porcelain and metal substructure. Considerable staining of the fractured veneer and metal framework shown in Fig. 1 suggests that bonding between the Co-Cr alloy framework and sintered porcelain material appeared to be insufficient for this FPD. This six-unit FPD, however, was repaired twice with overcasting restorations. One of the reasons is that the canine metal-ceramic restorations had been successively and successfully functioning as abutments for both the FPD and removable partial denture. In addition, the primarily seated overcasting on the left two incisors had been functioning for more than three years without detachment or fracture. The patient, therefore, preferred a second repair with overcasting rather than dislodging and re-fabrication of the FPD.

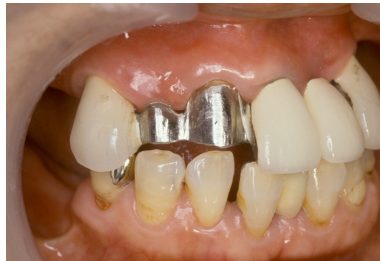
Fig. 2. Removal of porcelain.

The fractured porcelain veneer was removed with a high-speed diamond rotary cutting instrument. Area of preparation included the facial, incisal, and lingual surfaces of the casting (Fig. 2). A retentive hole was prepared at the edge of the central incisor abutment (Fig. 3).

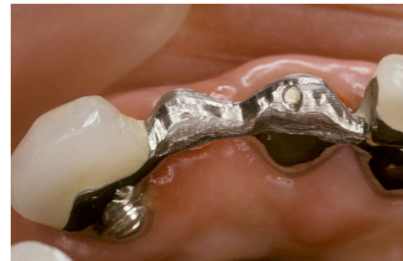
Fig. 3. Retentive hole in the incisor.

Repair of intermediate porcelain fracture is usually accomplished with a saddle-form overcasting. This type of casting is less retentive and more difficult to stabilize than a full cast restoration or three-quarter restoration. Additional preparation of a retentive hole in the current case helped to improve retention of the overcasting.^{1-3,5,6,9}

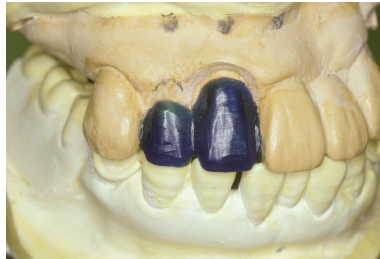
Fig. 5. Waxing of overcasting.

a die stone material (Fig. 4). A wax pattern was fabricated and the framework was cast with a gold alloy for metal-ceramic restorations (Degudent U, Degussa AG, Frankfurt, Germany) (Figs. 5 and 6). Feldspathic porcelain (VMK 68, Vita Zahnfabrik GmbH, Bad Säckingen, Germany) was applied to the casting (Fig. 7).

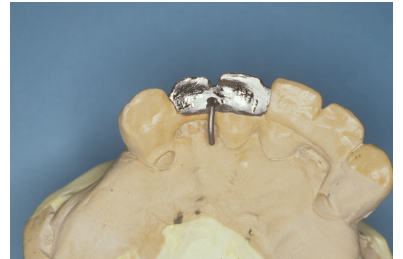
Fig. 6. Gold alloy framework.

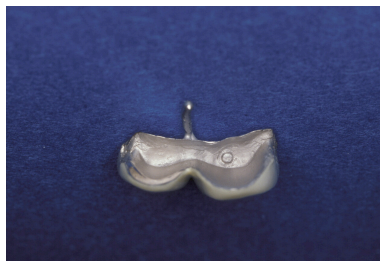
Fig. 8. Air-abrasion with alumina.

At the second appointment, the overcasting was tried-in, and the inner surface to be bonded was air-abraded with 70 µm alumina (Hi-Aluminas, Shofu Inc., Kyoto, Japan) by means of an airborne particle abrader (Jet-Blast II, J. Morita Corp., Suita, Japan) (Fig. 8). A single liquid metal priming agent (Alloy Primer, Kuraray Medical Inc., Tokyo, Japan) was applied to the overcasting (Fig. 9). The Alloy Primer material contained both 6-(4-vinylbenzyl-*n*-propyl) amino-1,3,5-triazine-2,4-dithiol, or dithione tautomer (VTD) and 10-methacryloyloxydecyl dihydrogen phosphate (MDP) in acetone. The abutment and pontic of the undercasting made of a cobalt-chromium (Co-Cr) alloy (Biocast, Rx Generic Corp., Wallingford, CT, USA) were isolated with a rubber dam. The adjacent teeth were protected against particle abrasion with a polymer-solvent coating agent (Protect Varnish, Kuraray Medical Inc.). The intraoral metal surface was also air-abraded with alumina with a hand-held air-abrader (Airbrush, Paasche Airbrush Co., Chicago, IL, USA) (Fig. 10). The Alloy Primer material was applied to the undercasting (Fig. 11). The overcasting was then seated with a tri-*n*-butylborane initiated adhesive resin (Super-Bond C&B, Sun Medical Co., Ltd., Moriyama, Japan) using a brush-dip technique (Figs. 12-14).

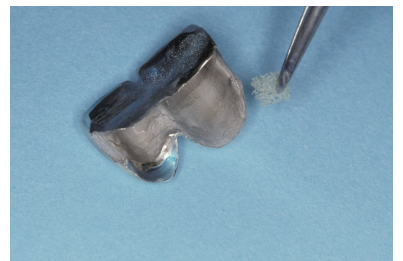
Fig. 9. Application of Alloy Primer.

A dual functional metal priming agent (Alloy Primer) that contains both the VTD thione monomer and the MDP hydrophobic phosphate monomer was used for seating the overcasting. According to the literature concerning adhesive bonding of dental casting alloys, VTD was effective for bonding noble metal alloys,^{17,18} whereas the MDP was effective for bonding base metal alloys.¹⁶ Considering the fact that adherend materials in the current case are Co-Cr alloy and gold alloy, it is reasonable to consider that MDP in the Alloy Primer agent

is effective for bonding the Co-Cr undercasting, and VTD is substantially effective for bonding the gold alloy overcasting.

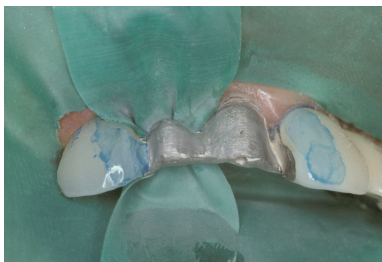
Fig. 10. Air-abraded undercasting.

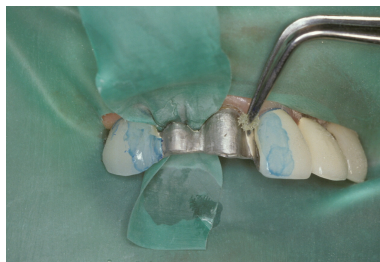
Fig. 11. Application of Alloy Primer.

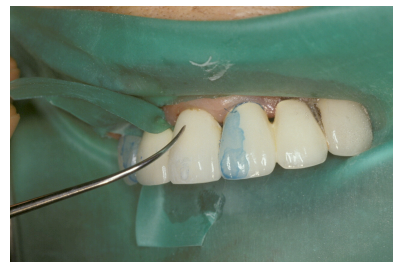
Fig. 12. Removing flew-out luting agent.

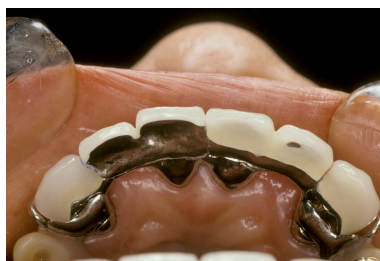
Figs. 13 and 14. Facial and incisal views of the seated overcasting.

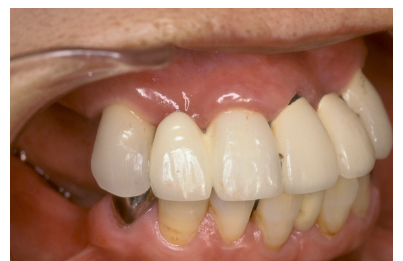
Fig. 15. The repaired FPD after one year and four months.

The patient was satisfied with the restoration and entered into a maintenance program. Fig. 15 shows the facial view of the overcasting restoration after one year and four months. During an observation period of two years and two months, the repaired FPD functioned satisfactorily.
