Clinical application of a tri-*n*-butylborane initiated adhesive resin filled with pre-polymerized composite particles

A tri-*n*-butylborane (TBB) initiated adhesive resin with pre-polymerized filler particles (Bondfill SB) has been released. This article describes bonding technique and short-time clinical performance of the adhesive. The materials and procedure reported here are applicable as an option of the restorative treatments for the patients incompatible to currently available materials. (*Asian Pac J Dent* 2011; 11: 61-65.)

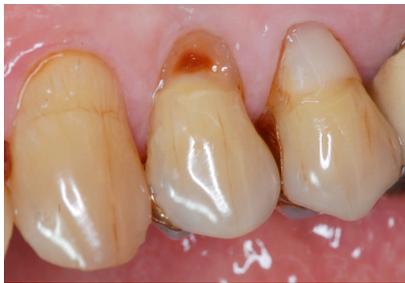
The patient felt cold-water pain after detachment of composite restoration of the maxillary premolar (Fig. 1).

Fig. 1. Premolar dental caries

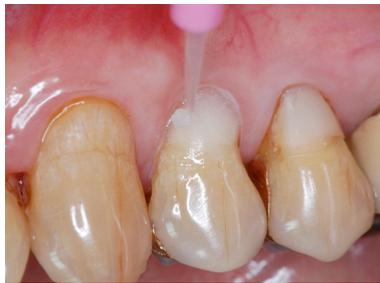
The tooth surface was minimally reduced with a diamond rotary cutting instrument. The Teeth Primer was applied to the non-retentive reduced surface and air-dried. The Bondfill SB resin (Medium Powder) was filled into the cavity with a brush-dip technique (Fig. 2). The excess material was removed and the surface was polished with silicone rotary instruments (Fig. 3). After the restoration, the cold-water pain was disappeared immediately.

Fig. 2. Filling the Bondfill SB

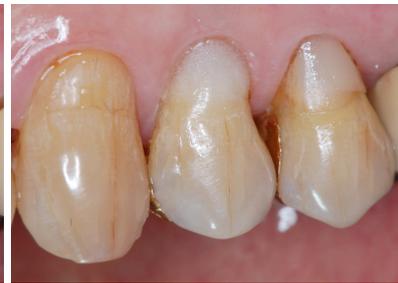
Fig. 3. Post-operative view

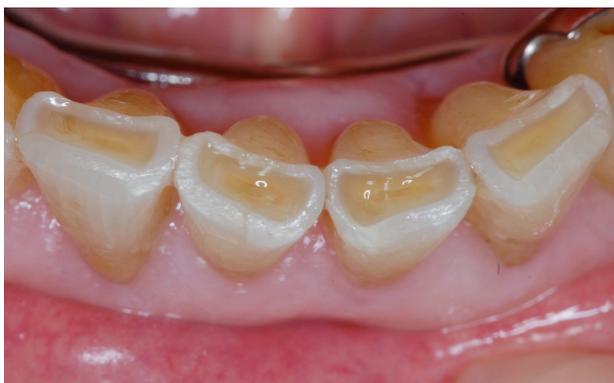
An aged patient was seen with a chief complaint of uncomfortableness of anterior dentition derived from tooth wear. Examination revealed severe attrition of mandibular incisors with steps along the dentino-enamel junction (Fig. 4). The tooth surface was slightly reduced with a diamond rotary instrument. The Teeth Primer was applied to the incisal areas and air-dried (Fig. 5). The Bondfill SB resin (Light Powder) was filled into the cavity with a brush (Fig. 6). The surface was polished with silicone rotary instruments (Fig. 7). Smoothness of the incisal area was recovered after the restoration.

Fig. 4. Worn incisors

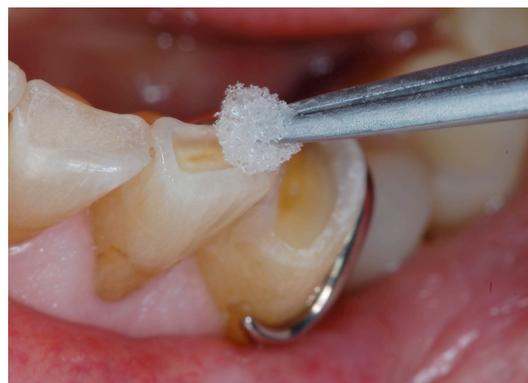
Fig. 5. Application of the Teeth Primer

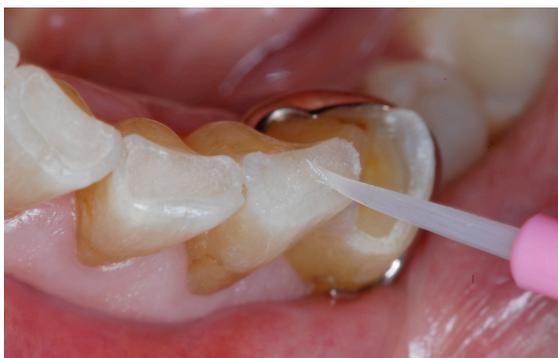
Fig. 6. Filling the Bondfill SB resin

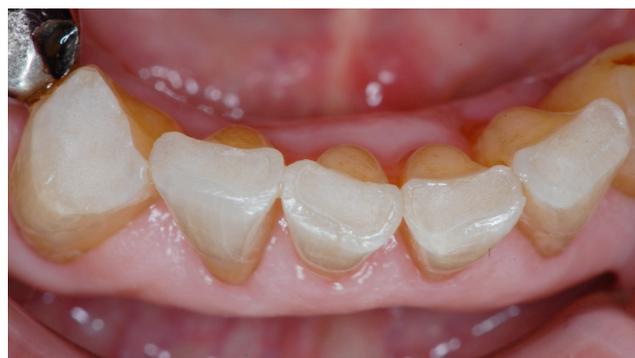
Fig. 7. Restored surfaces

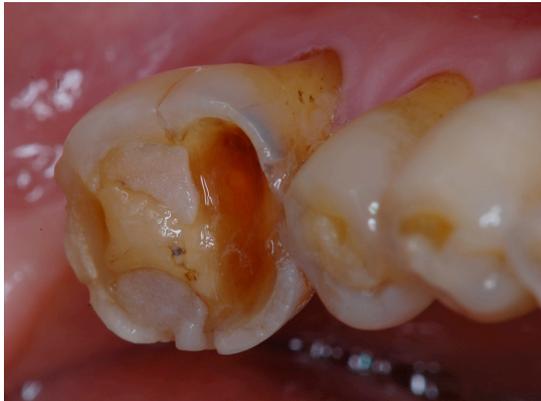
The patient preferred carbonated beverages, and occlusal planes of mandibular molars were attrited considerably (Fig. 8). The tooth surface was reduced and the Teeth Primer was applied. The Bondfill SB resin (Light Powder) was then filled into the defects with a brush (Fig. 9).

Fig. 8. Attrited mandibular molar

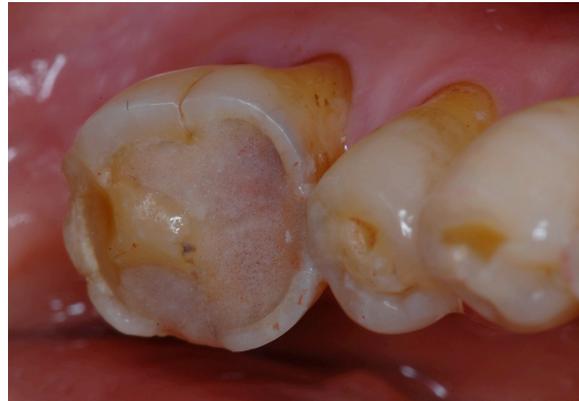
Fig. 9. Bondfill SB restoration

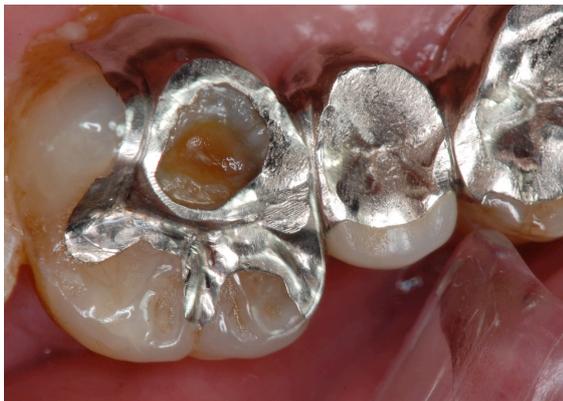
Secondary dental caries was detected along the interface between the centric holding cusp and the resin-bonded retainer (Fig. 10). The recurrently decayed tooth structure was removed, the Teeth Primer was applied, and the Bondfill SB resin (Light Powder) was filled into the cavity (Fig. 11).

Fig. 10. Secondary dental caries under the retainer

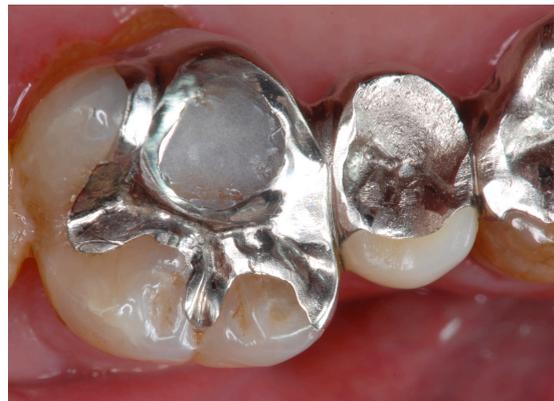
Fig. 11. Restoration with the Bondfill SB

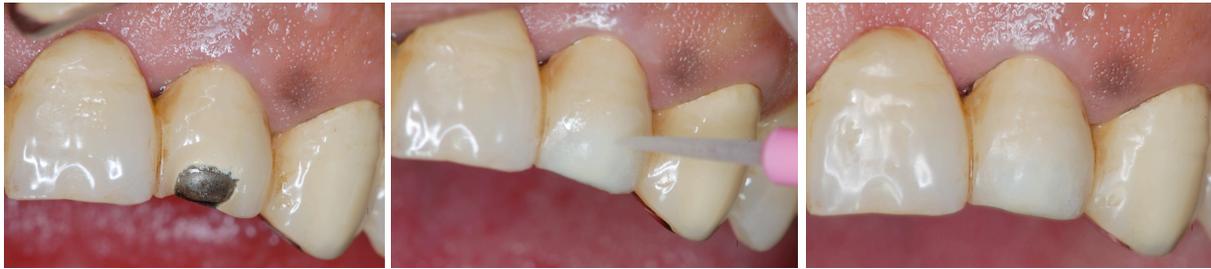
A patient with fractured composite resin veneered restoration was seen (Fig. 12). The patient requested one-visit repair. The fractured area was reduced with a diamond rotary cutting instrument, and the V-Primer (Sun Medical Co., Ltd.) was applied to the metal surface to be repaired. The V-Primer contains 6-(4-vinylbenzyl-*n*-propyl) amino-1,3,5-triazine-2,4-dithione (VTD) and effective only for noble metal alloys.⁴ The Bondfill SB resin with Medium Powder was applied to the incisal coping surface and the metallic color was masked (Fig. 13). The Bondfill SB resin with Light Powder was layered on the primarily placed material (Fig. 14). The repair was completed within a short period.

Fig. 12. Fractured veneer

Fig. 13. Repairing with the Bondfill

Fig. 14. Completed repair

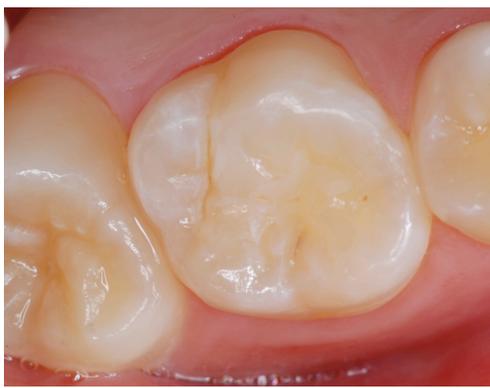
The TBB resins were developed originally as an adhesive for orthodontic brackets as well as a pit and fissure sealant (Fig. 15). A phosphoric acid etchant (High-viscosity, Red) was applied (Fig. 16), rinsed with water, and air-dried. The Bondfill SB resin was filled into the pits and fissures (Figs. 17 and 18).

Fig. 15. Pre-operative view

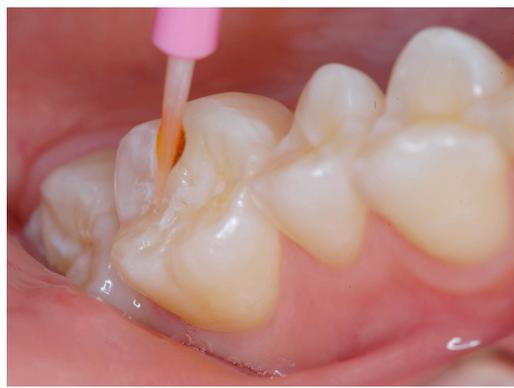
Fig. 16. Etching with phosphoric acid (Red)

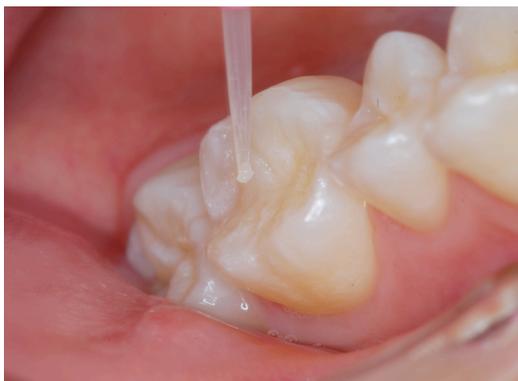
Fig. 17. Application of the Bondfill SB

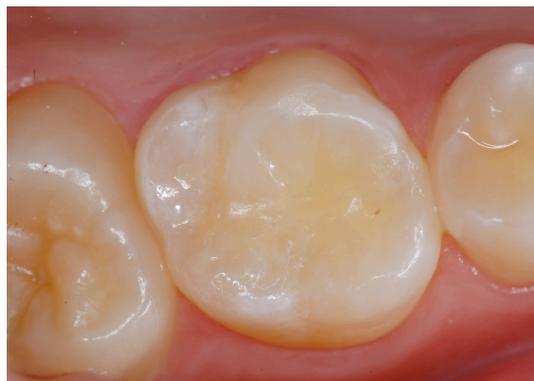
Fig. 18. Sealed pits and fissures

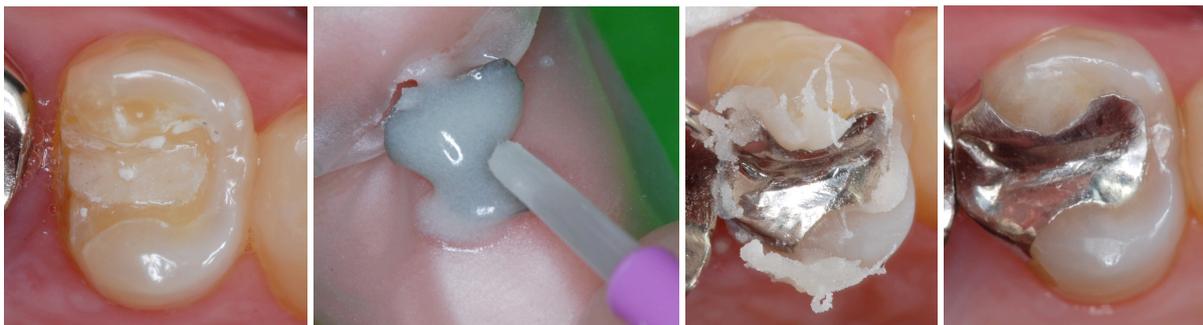
Fig. 19. Inlay cavity

Figs. 20, 21. Application of adhesive after priming

Fig. 22. Seated restoration

Detachment of inlay restoration is sometimes experienced in relation with shallow cavities (Fig. 19). Prior to re-seating the restoration, the metal surface was air-abraded with alumina, followed by priming with the V-Primer, when the material was a noble metal alloy (Fig. 20). The restoration was seated with the Bondfill SB resin (Figs. 21 and 22). Probability of detachment will be reduced by application of the bonding system shown in this case.
